BY KYLE DIAMOND

## Fixing a Poorly Flashed Cupola

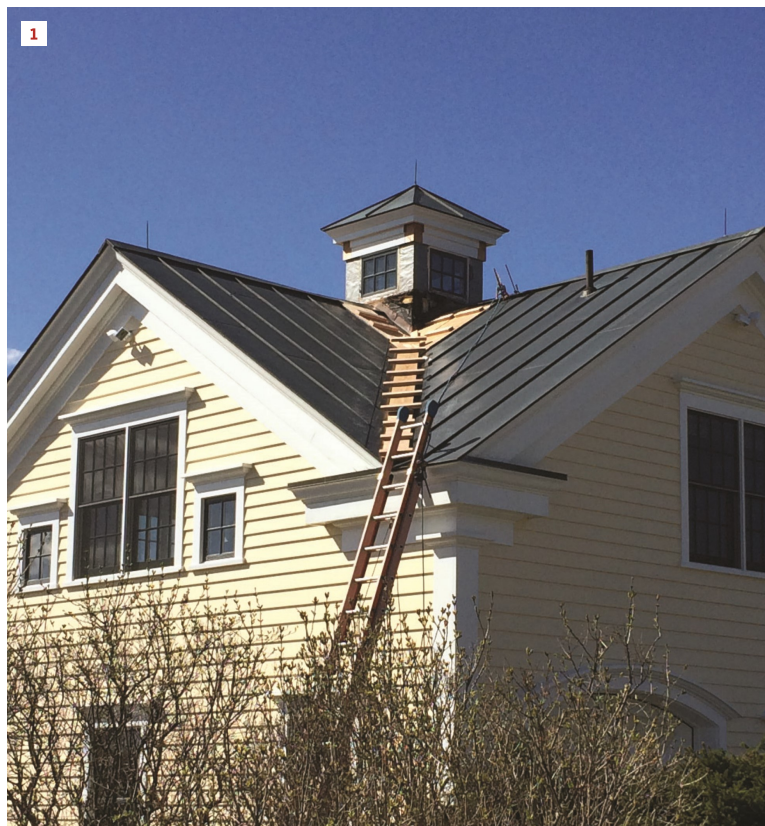
**Last fall, my company was asked** to investigate a roof leak originating from a cupola atop an attached carriage-house garage (1). From the exterior, nothing appeared to be wrong with the cupola or the surrounding roof. But the inside was a different story. The house was fairly new, approximately 10 years old. Above the garage was a guest bedroom with a cathedral ceiling that reflected the roof's four valleys. At the peak, the cupola, with its four awning windows, served as a light well. According to the homeowners, there had been gradual, periodic leaking around the interior light well since the home's initial construction. After a particularly bad storm last summer, the water staining worsened, prompting them to remove the damaged

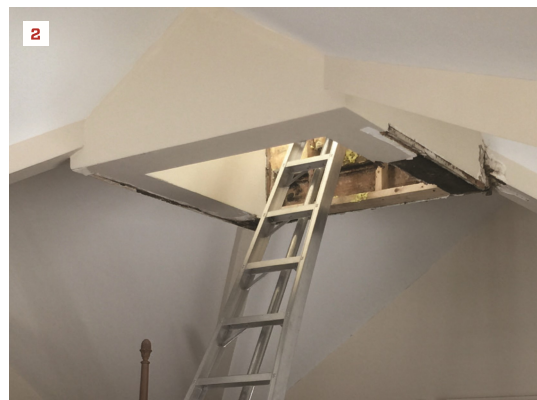
drywall—exposing open-cell-foam-filled stud bays and water damage to the framed enclosure (2). That's when they called us.

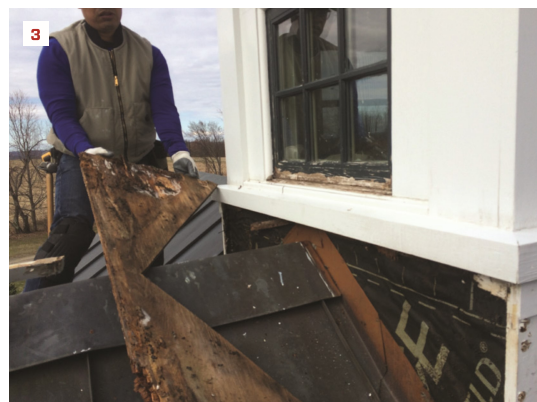
We began our investigation by removing the outer, plywood-clad finish base of the cupola (3). The copper roof-to-wall flashing had been reverse-flashed, with the copper placed on the outer surface of peel-and-stick—the previous builder had omitted the housewrap, which could have easily lapped the vertical leg of the roof-to-wall flashing. Another red flag was that sheathing behind the peel-and-stick at the top of the base felt spongy, which led us to remove the cedar corner boards and wrap-around sill (4). We then discovered that where the cupola's upper portion transitioned to its wider, lower base, there was no flashing; the upper portion's Tybar drainage plane dumped onto the 2-inch-wide, exposed plywood strip at the stepped-out base (5).

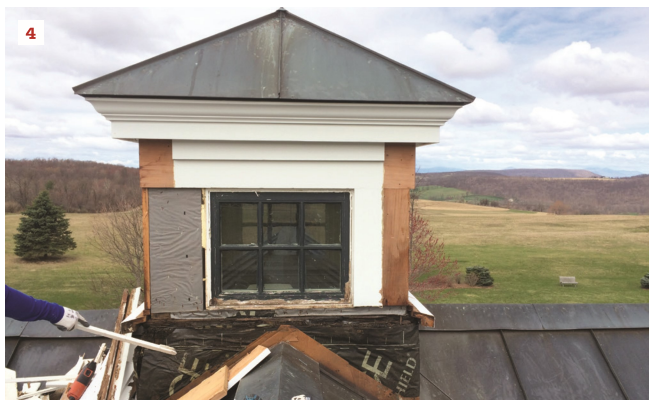
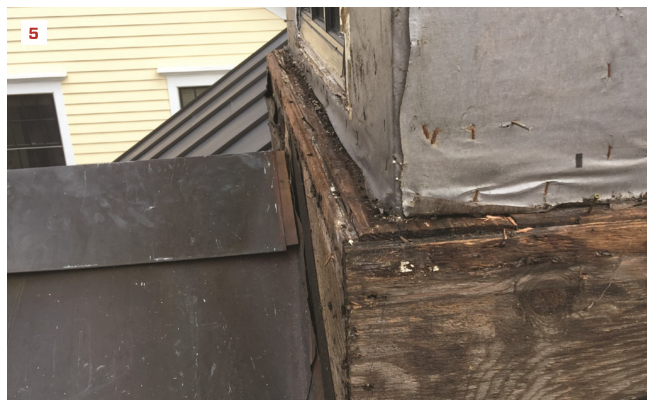
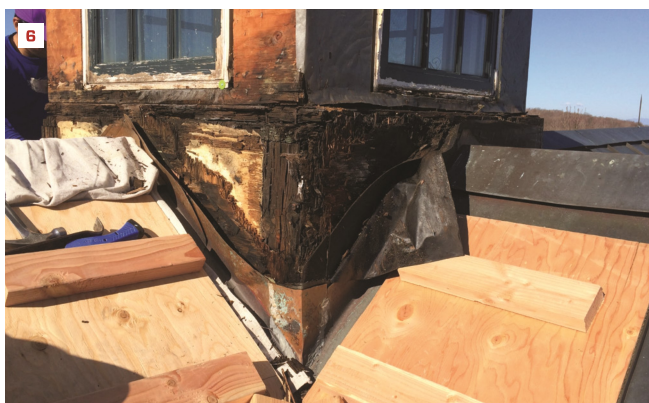
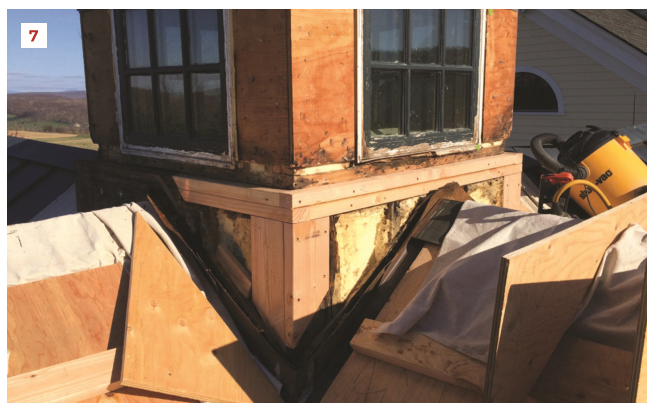
workmanship on the cupola was a whole bowl of “wrong.” There should have been either pan flashing installed under the existing cedar wrap-around sill or a metal cap installed over it. Without such details, this handsome architectural feature had become a conduit for water.
