Greek Revival Column Repair

by Kyle Diamond

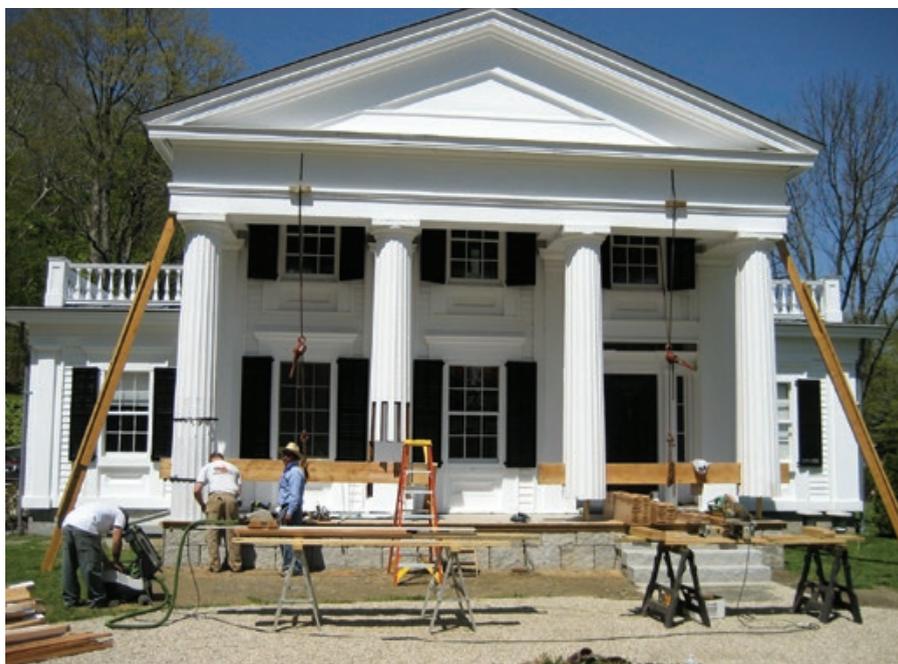
Repairing the colonnade involved rebuilding the porch, replacing rotted sections at the bottom of the non-structural columns, and eliminating makeshift plywood plinths (above) that had been added in an earlier repair attempt. The cantilevered portico was braced to prevent sagging, and the columns were held in place in pairs using 2x12s rigged to come-alongs anchored to the pediment above.

roof. This meant that before removing the column bottoms and existing porch, we only needed to install diagonal bracing to keep the portico from sagging (see top left photo, previous page). And because the four columns were not load-bearing, we just had to keep them from moving. We supported each pair with a 2x12 chained to a come-along that in turn was fastened to a metal strap fed through a hole drilled through the pediment.

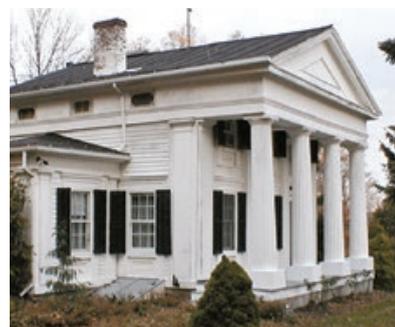
story. Working with the owners on the design to refurbish the entry, we decided to re-frame the front porch with pressure-treated lumber, install new fir tongue-and-groove decking, and add stone steps and a stone-veneer foundation. Along with repairing the columns — which stand 13½ feet tall and taper from 25 inches in diameter at the bottom to 20 inches at the top — we would restore the colonnade to its proper “Doric order,” with the shafts of the columns bearing directly on the new porch deck. This meant eliminating the simulated plinths, which had been built from plywood boxes in an earlier effort to replace rotted column bases (see photo, above right).
