Greek Revival Column Repair

by Kyle Diamond

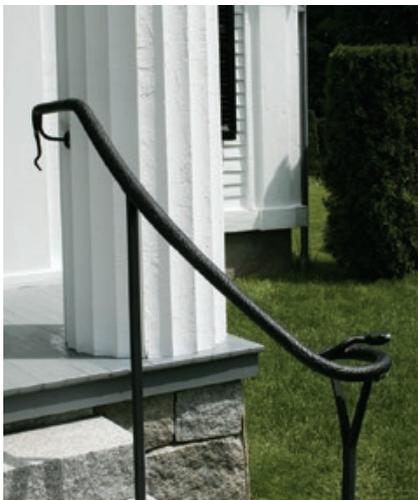
Figure 4. As a final touch, the clients — who named the house “Copperheads” as a joke because of their red hair — commissioned custom handrails in the shape of snakes. They were made and installed by Horst Around the House in LaGrangeville, N.Y.

Finishing up. We did a pretty good job fitting the joints — the only wood filler we needed was for the screw counter-sinks. When it came to painting the columns, the clients had requested that we try to match the rough texture of the upper columns and pediment. After 160 years of paint being applied over old paint that wasn’t properly scraped, the existing wood had a rough, scaled finish surface. To duplicate the texture, we applied DAP acrylic caulk with a putty knife, giving the new wood the appearance of aged, scaling paint. For the top coat, we used an acrylic paint by California Paints. The final touch was the installation of custom-made handrails (**Figure 4**).
